Bulkhead MASTERCLASS

They are one of the most rot-prone areas on a Land Rover and equally tricky to repair. Kev Mills visits Ashtree Land Rover International to see how a professional does it

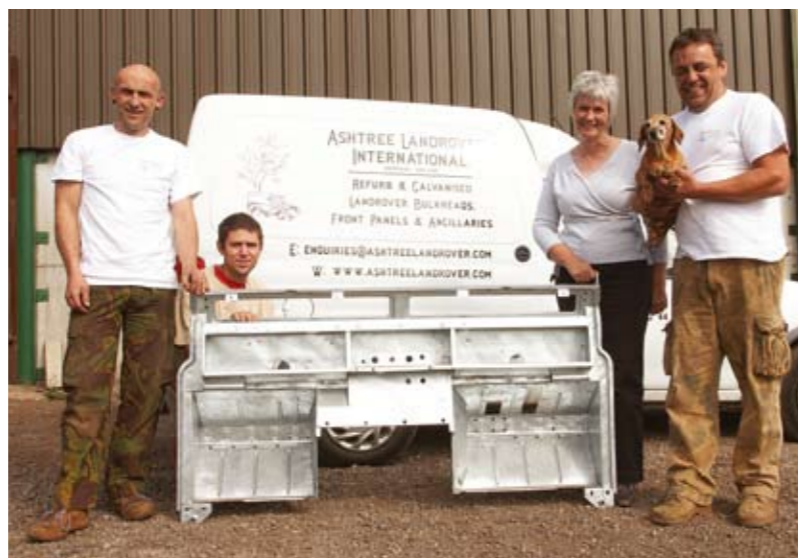
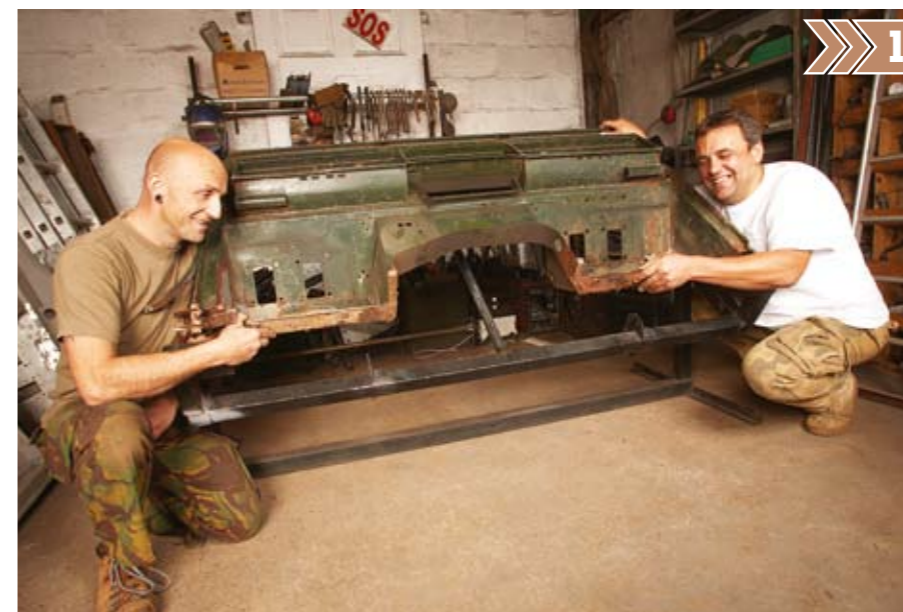
1 Kev and Lyn start by placing the bulkhead in their special jig and thoroughly inspecting it. ‘As long as you have the dash and the centre section’, says Lyn, ‘there’s enough to work with. Some need more work than others, but there aren’t many we have to write off completely.’

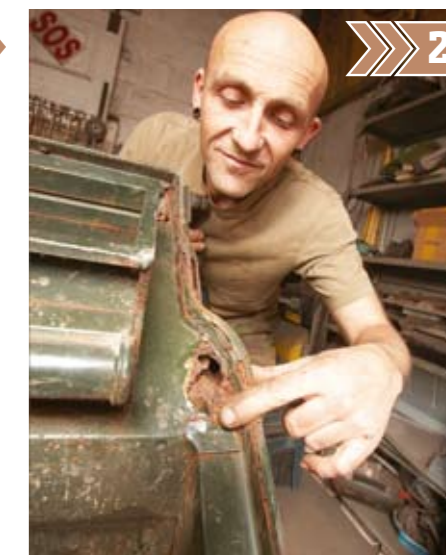
2 Door pillar/shut: this area isn’t available as a repair section, so will have to be fabricated. This area is triple-layered for strength, so unless the rot is fully cut out and the metal replaced, any rust will be trapped.

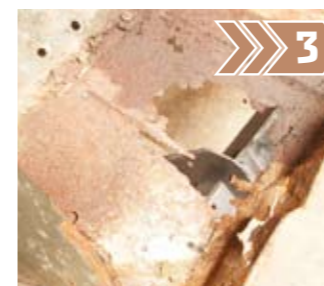
3 Rotten footwells – typical of many older Land Rovers. If the top half is still solid, these can be repaired, otherwise a complete new footwell is required. This one has already been patched at one stage...

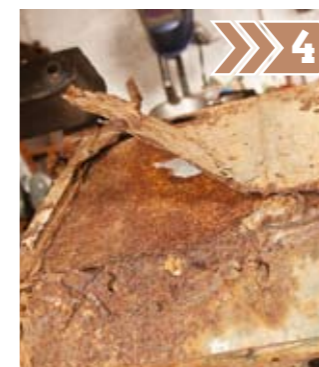
4 ...but the original rotten metal was left underneath the patch and has now ‘blown’ away from the repair.

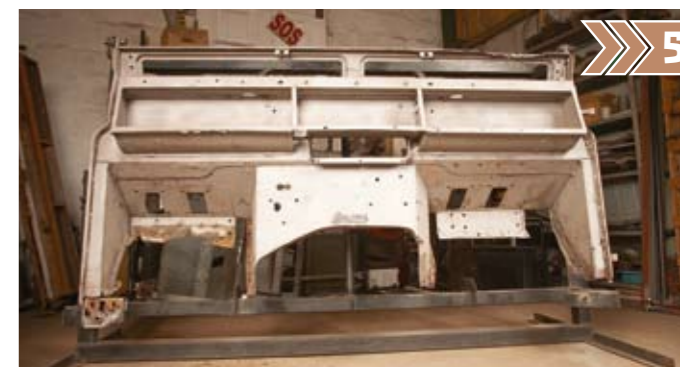
5 Many bulkheads will have years of layers of paint, possibly filler and all sorts of other nasties underneath the surface. The best approach is to get the bulkhead shotblasted, removing any loose rust and leaving clean metal to work with.

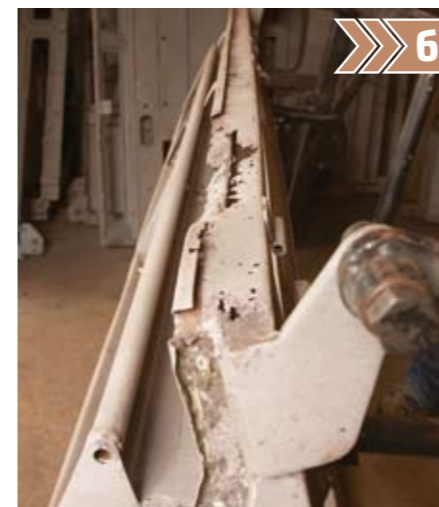
6 The top rail is often badly rotted. Water collects under the windscreen and is trapped by the sealing rubber. This one’s been hidden by paint, but is a relatively easy repair...

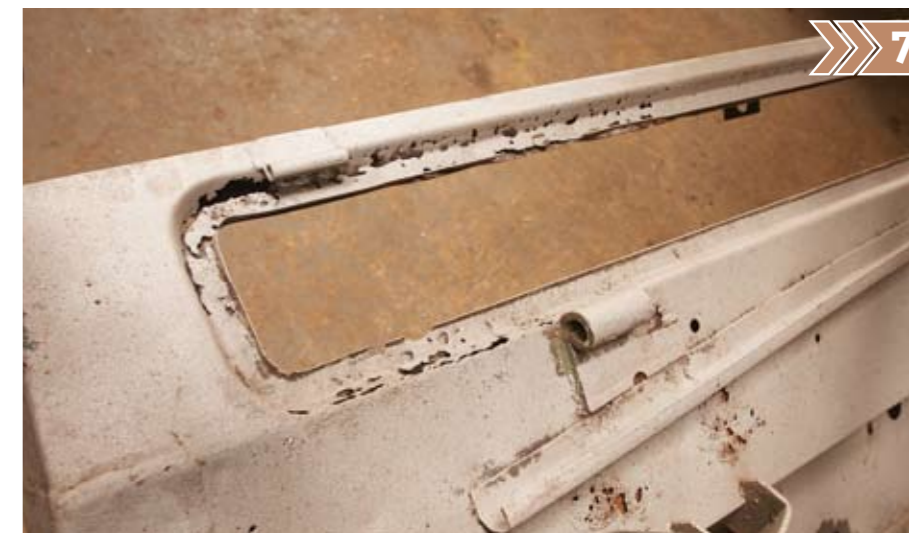
7 ...Unlike the area around the vent flaps. ‘This really isn’t a job for the faint-hearted’, says Kev. ‘It will take as long to repair this section as it will to replace a footwell and door pillar. The really bad ones are put to one side and done on a ‘as and when’ basis.’

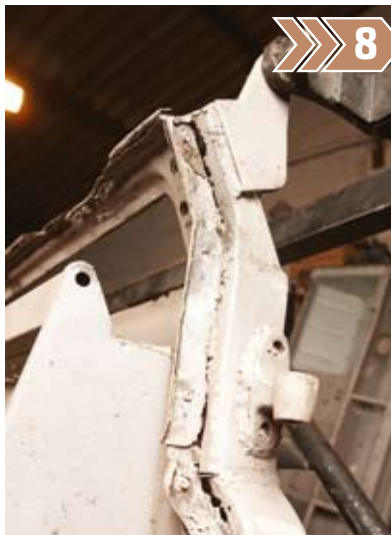
8

Typical of previous owner bodes is this welded-on top door hinge. 'This means a otherwise solid top corner will need rebuilding to get back to standard', Kev explains. 'We see some right lash-ups. As well as filler, we've found complete pages of a 1970s-era Cornish newspaper and even repairs using concrete!'

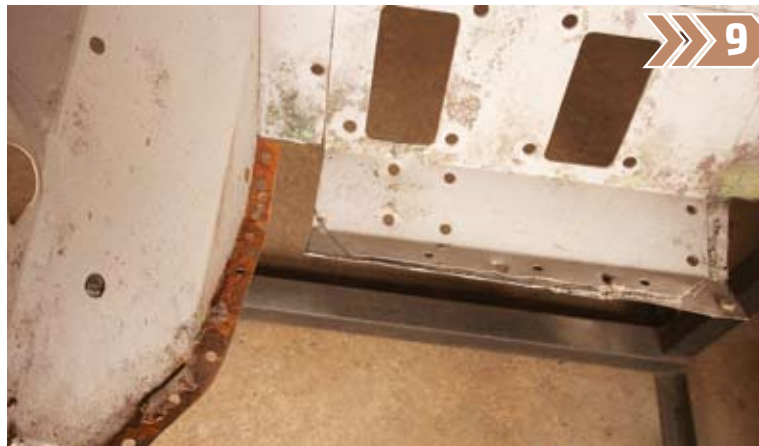
9

Footwells and stiffeners are held in by spot welds. 'We drill these out and remove the complete sections, enabling us to keep the construction similar to original and also remove trapped rust.'

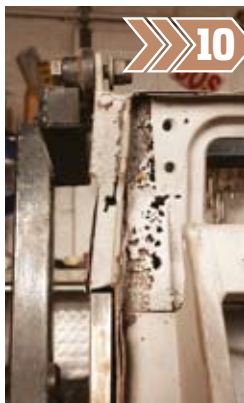
10

Ideally, the top of the bulkhead and windscreen hinge and are held tight in a jig while the door pillar is cut out and replaced. 'Series I, II and IIA bulkheads are the easiest to repair in this way as the dash tray keeps everything stiff - important for the galvanizing later.'

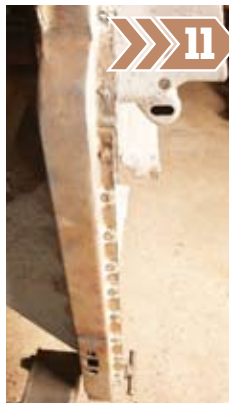
11

Here we see where the door pillar joins the footwell. 'We puddle-weld in the same place they were originally spot welded, for strength and appearance. The lip for the door seal can be added if needed, but more people are using the one-piece Defender-type seals which don't need the lip.'

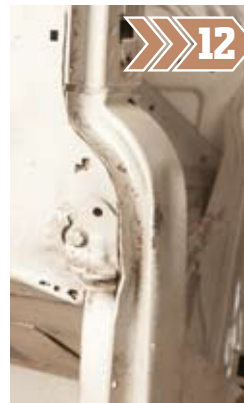
12

A typical fault with Series and Defender bulkheads: the door has swung open too far, tearing the stay bracket away and denting the pillar itself. Despite having no rot, this will all have to be cut out and replaced to get a decent job.

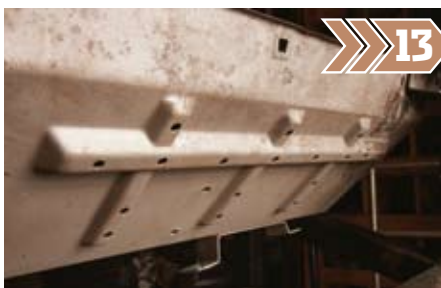
13

Defender footwells are a different shape to Series and at present replacements are not available. 'As a result, we repair them using parts of other bulkheads which have rotted in different places', explains Lyn.

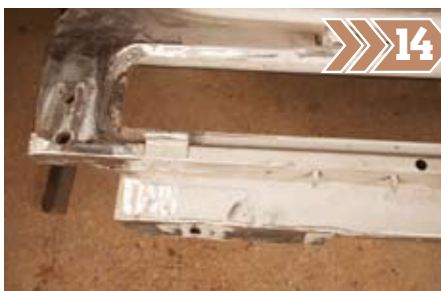
14

Similarly repaired is this Lightweight top bulkhead, which was rotted right through in the top corners. After blending the new metal in, it's time for galvanizing.

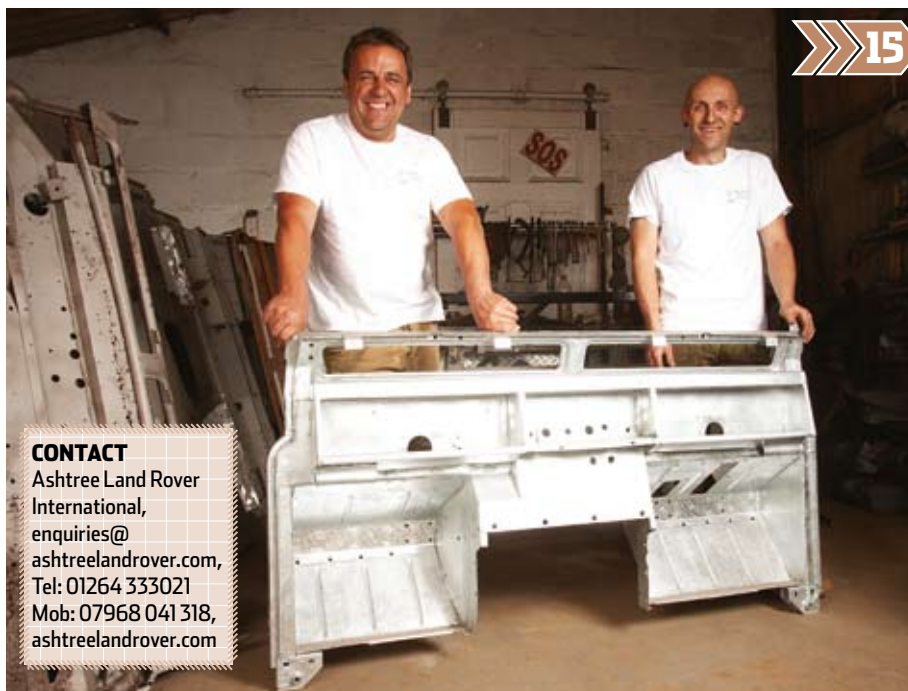
15

Lyn and Kev show off a finished bulkhead for a six-cylinder Series IIA. 'We have very few problems with the galvanizing as the guys at the plant have really got the hang of them now. We drill a few extra holes in the closed sections and a couple in the top to allow the gases to escape and the galv to flow into all the nooks and crannies.' The finished bulkhead is cleaned up and all threads re-tapped ready for assembly. There's 25 microns of galv on each of these bulkheads, losing on average .5 microns a year. In theory, this means it will last for 175 years!
